1 **PRUDENTIAL BUILDINGS: REPORT OF**

2 **WILLIAM M. EWING, CIH**

3
4 **I. INTRODUCTION AND BACKGROUND**

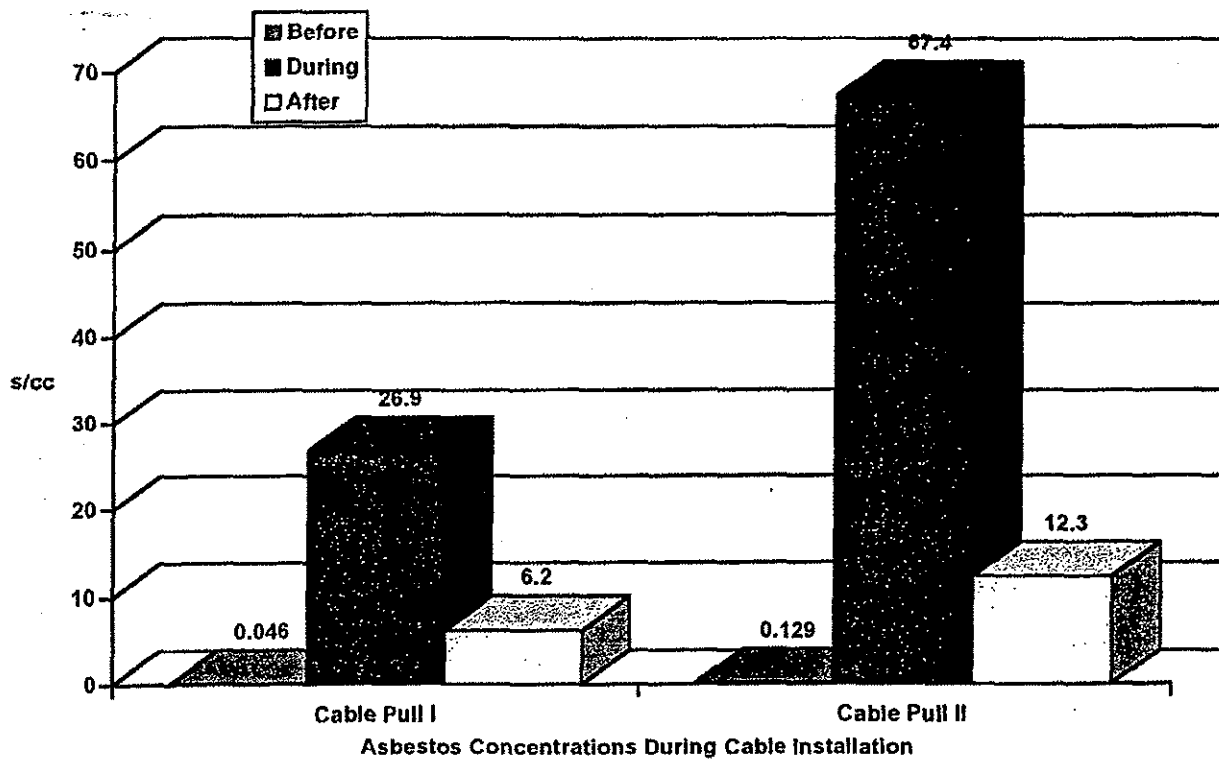
Figure 1. Episodic Exposure Results Before, During and After Installation of Cables in the Vicinity of High Density Fireproofing

DESCRIPTIVE STATISTICS OF ASBESTOS CONCENTRATIONS

Cable Pull I				
Phase	Arithmetic Mean (s/cm ³)	Arithmetic		Number of Observations
		Std. Dev. (s/cm ³)	Geometric Mean	
Before Inst.	0.052	0.030	0.046	5
During Inst.	28.9	12.6	26.9	5
During (Pers.)	10.5	11.6	7.1	3
After Inst.	8.4	7.0	6.2	6

Cable Pull II				
Phase	Arithmetic Mean (s/cm ³)	Arithmetic		Number of Observations
		Std. Dev. (s/cm ³)	Geometric Mean	
Before Inst.	0.158	0.094	0.129	5
During Inst.	100.2	91.9	67.4	4
During (Pers.)	124.8	85.6	102.7	3
After Inst.	17.0	13.5	12.3	4

1 in buildings with spray-applied fireproofing which was the same or substantially similar to
2 the fireproofing in the Prudential Buildings. The results of these studies have been
3 published in peer-reviewed journals and are summarized in Figures 1 - 5.^(87, 89, 90)

4
5 In each of the five studies a particular maintenance, renovation or custodial activity was
6 chosen. Area air sampling was conducted before, during, and after each activity. Personal
7 air samples were also collected on the individuals performing the activities. All samples
8 were analyzed by transmission electron microscopy (TEM) and the personal samples were
9 analyzed by TEM and phase-contrast microscopy (PCM). In each study it was found that
10 the asbestos exposures during the activity increased significantly when compared to
11 concentrations in the air before the activities began. In each instance, the source of the
12 asbestos exposure was the fireproofing, or the dust and debris from the fireproofing.

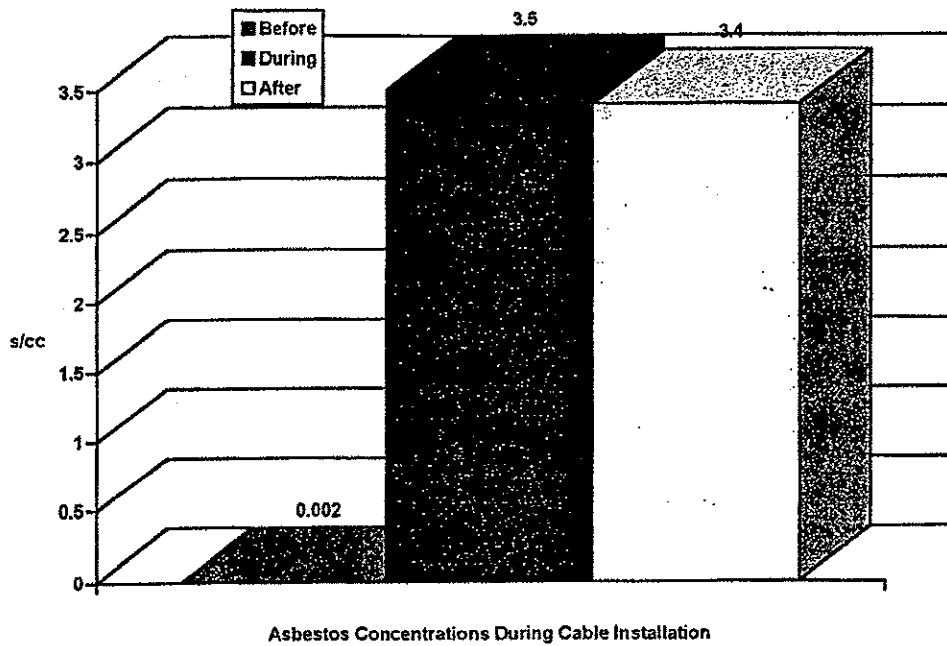
Figure 2. Episodic Exposure Results Before, During and After Installation of Cables in the Vicinity of Low Density Fireproofing

DESCRIPTIVE STATISTICS OF ASBESTOS CONCENTRATIONS

Phase	Arithmetic Mean (s/cm ³)	Arithmetic Std. Dev. (s/cm ³)	Geometric Mean	Number of Observations
Before	0.006	0.014	0.002	5
During (Area)	3.6	0.84	3.5	5
During (Pers.)	26	7.5	26	2
After	3.8	1.9	3.4	5

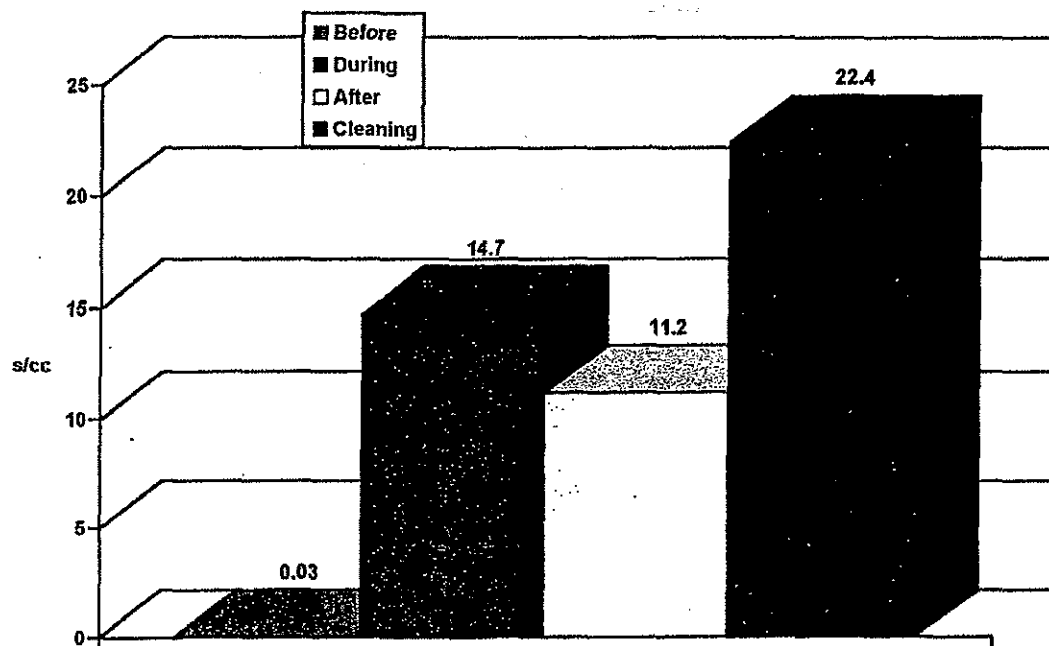
Figure 3. Episodic Exposure Results Before, During, and After Replacement of Ceiling Tiles Below Fireproofing

Asbestos Concentrations During Ceiling Tile Replacement

DESCRIPTIVE STATISTICS OF ASBESTOS CONCENTRATIONS

ND = No Asbestos Structures Detected

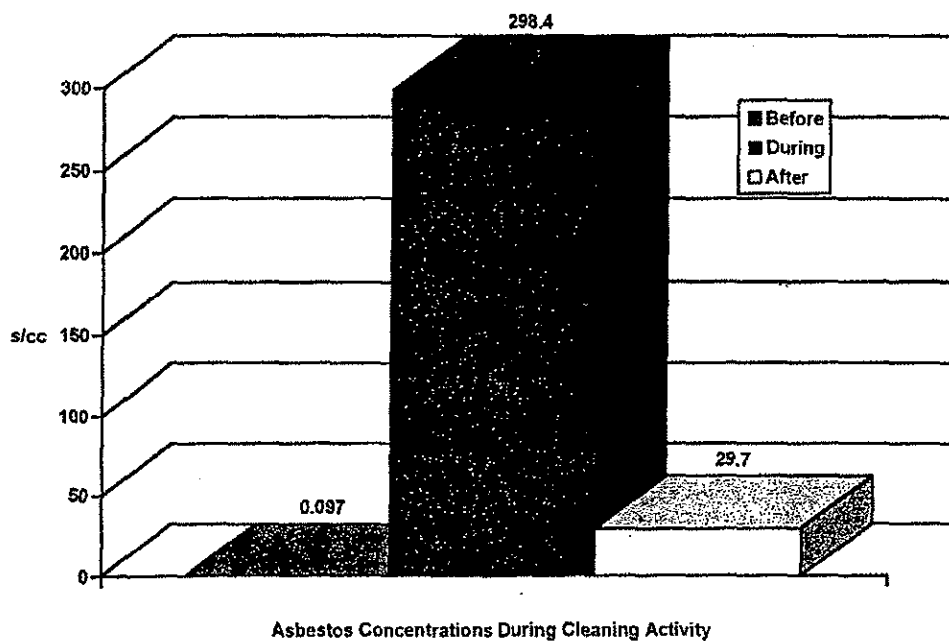
Figure 4. Episodic Exposure Results Before, During and After Cleaning a Storage Room in a Building with Fireproofing

DESCRIPTIVE STATISTICS OF ASBESTOS CONCENTRATIONS

Phase	Arithmetic Mean (s/cm ³)	Arithmetic Std. Dev. (s/cm ³)	Geometric Mean	Number of Observations
Before - Inside	0.264	0.221	0.097	5
During - Inside	329.9	173.0	298.4	5
During - Inside (Personal)	343.8	360.6	237.1	3
After - Inside	31.8	12.3	29.7	5

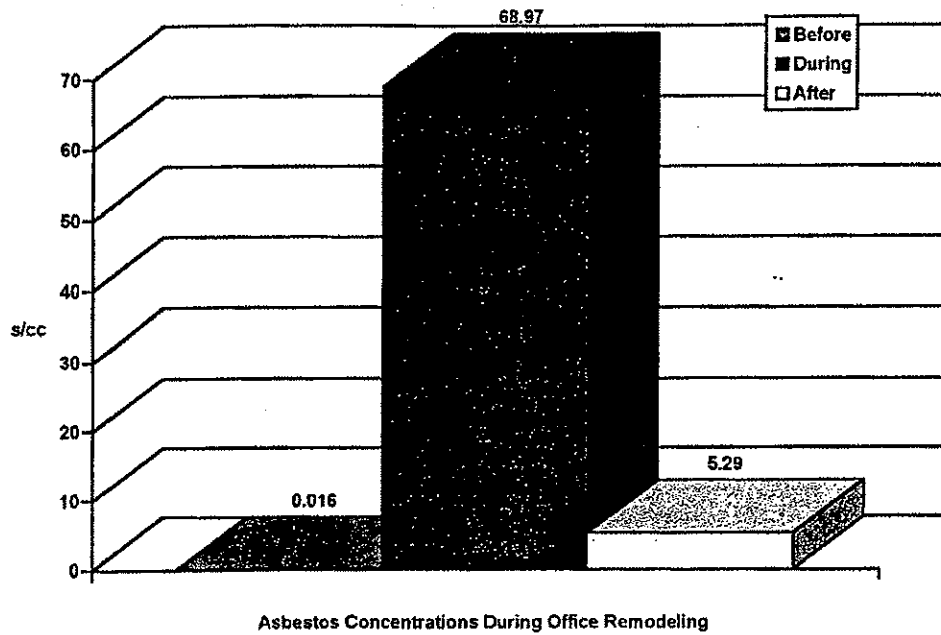
DESCRIPTIVE STATISTICS OF ASBESTOS CONCENTRATIONS

Phase	Arithmetic Mean (s/cm ³)	Arithmetic Std. Dev. (s/cm ³)	Geometric Mean	Number of Observations
Before	0.045	0.048	0.016	5
During (Area)	73.32	27.08	68.97	6
During (Pers.)	150.79	164.68	71.60	4
After	5.81	2.39	5.29	4

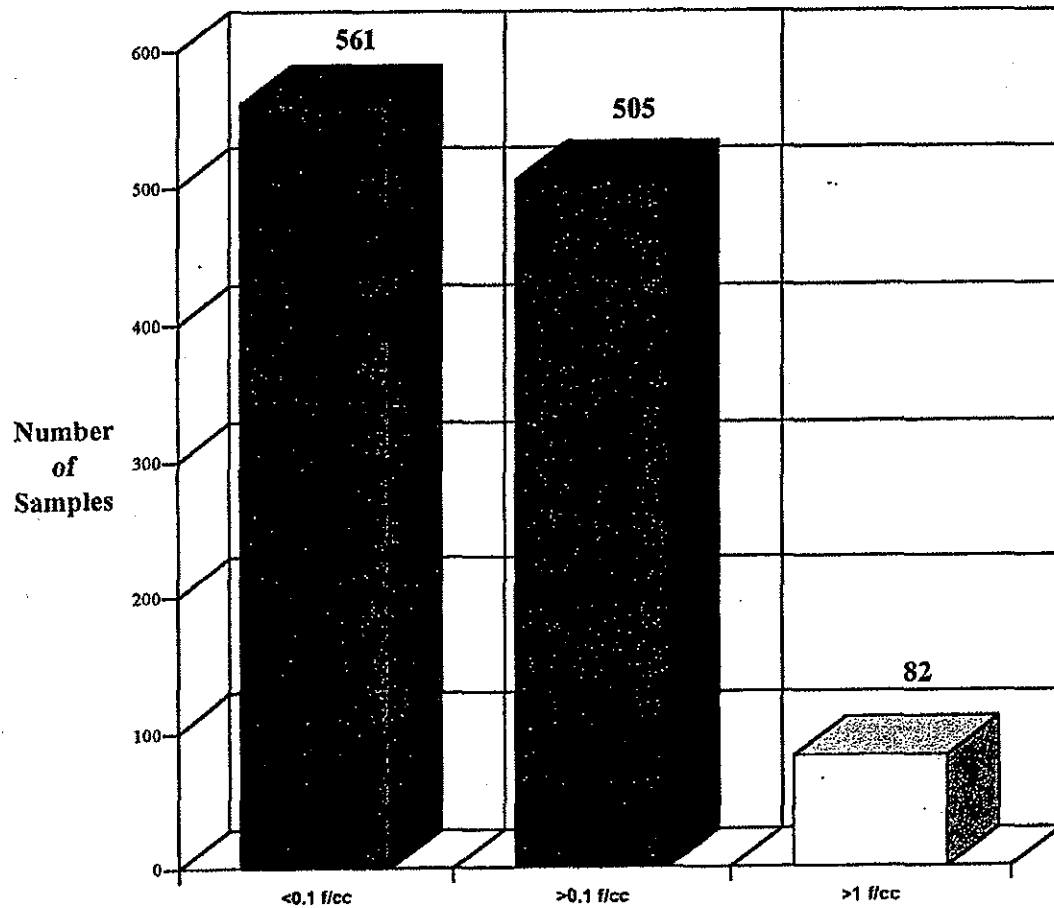
Figure 6. Distribution of Fiber Concentrations Measured on Persons Performing Maintenance and Renovation Activities in Prudential Buildings (1066 samples)

17
18 A total of 1097 samples (1066 personal samples, 31 area samples) are included in the data
19 set. Of these, 22 samples are reported as overloaded and 3 samples were reported voided.

20
21 Of the 1066 personal samples, 505 (47%) were greater than or equal to 0.1 f/cc and 82
22 (8%) were greater than 1 f/cc. These results are depicted in Figure 6. These results are

1 consistent with results reported in the published literature and further demonstrate that
2 maintenance and renovation activities in buildings with spray-applied friable fireproofing
3 routinely cause elevated airborne exposures.
